TEST REPORT NO. ELA/L-221.181/12
SAFETY NET
TENSILE STRENGTH

CLIENT: **EQUIPESCA EQUIPAMENTOS DE PESCA LTD.**
 Located at Rua Henrique Veiga, 41 – Fazenda Santa Genebra
 13080-290 – Campinas – SP
 Ref.: (57759)

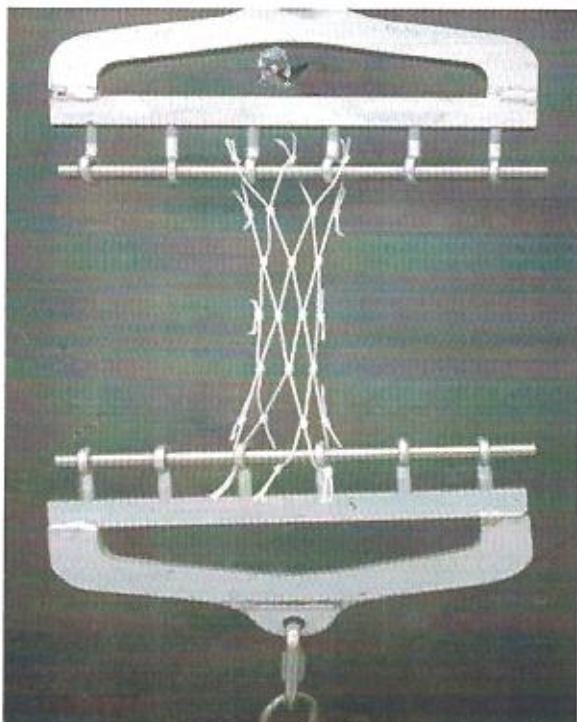
Fig. 1 – Longitudinal tensile strength

TEST	MEASURED VALUES						STANDARD DEVIATION
	CP 01	CP 02	CP 03	CP 04	CP 05	MEAN/MESH	
Ultimate longitudinal tensile strength	1492	1563	1583	1589	1593	521	41.91
Ultimate transverse tensile strength	1593	1505	1559	1628	1628	528	51.78
SPECIFIED VALUE						320 N/mesh (mín.)	2.5% (máx.)

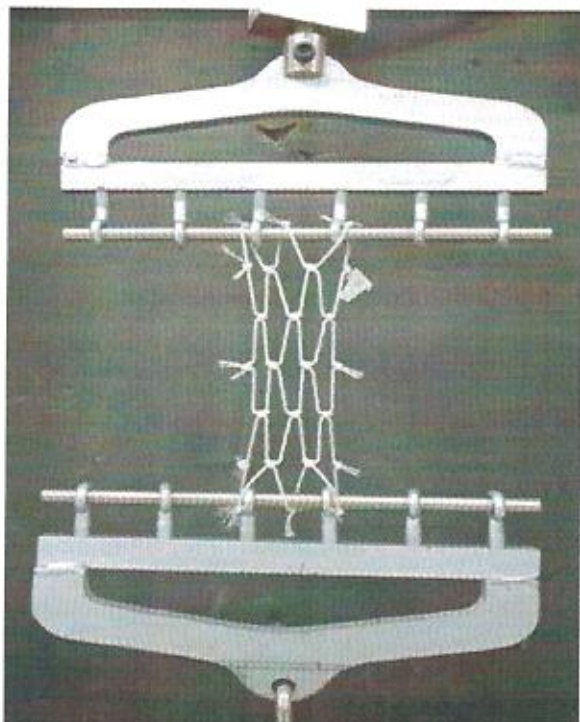
Fig. 3 – Longitudinal tensile strength

TEST	MEASURED VALUES						MEAN/MESH	STANDARD DEVIATION
	CP 01	CP 02	CP 03	CP 04	CP 05			
Ultimate longitudinal tensile strength, N	967.9	979.7	1207.2	1067.0	1157.2	357	105.9	
Ultimate transverse tensile strength, N	1520.1	1047.4	1110.1	1258.2	1698.5	442	276.3	
SPECIFIED VALUE						320 N/mesh (mín.)	2.5% (máx.)
